Article

Evaluation of Over-The-Row Harvester Damage in a Super-High-Density Olive Orchard Using On-Board Sensing Techniques

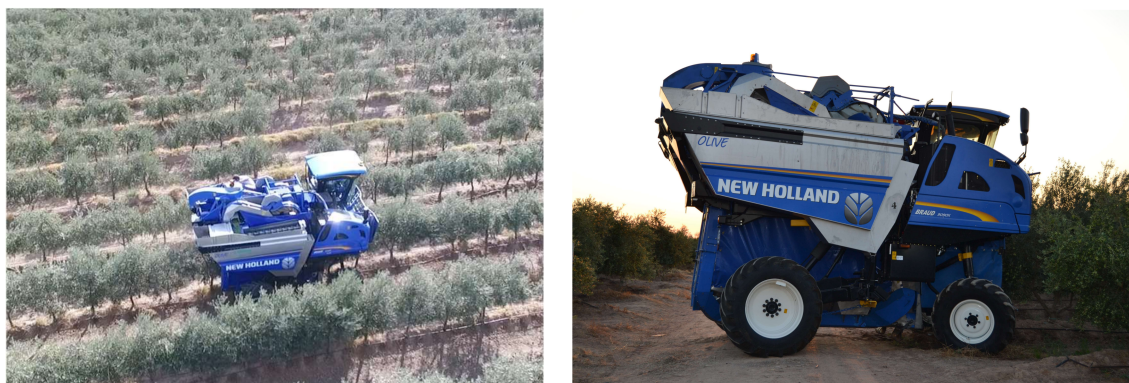
The harvesting operation was performed using a straddle harvester (New Holland Braud 9090X Olive, CNH Global, Zedelgem, Belgium) (Figure 1). This machine is characterised by a beater with bow-shaped poles, a conveyor belt transport system with buckets, and a mixed pneumatic and mechanical cleaning apparatus comprising four extractors and a stalk remover. Two of the extractors were positioned beneath the beater, and two were above the stalk remover. The 'Manzanilla Cacereña' variety was harvested on September 26th and the 'Manzanilla de Sevilla' variety was harvested on the 30th of the same month, after the pigmentation of the skin became green-yellowish.

Figure 1. Straddle harvester used in the trial.

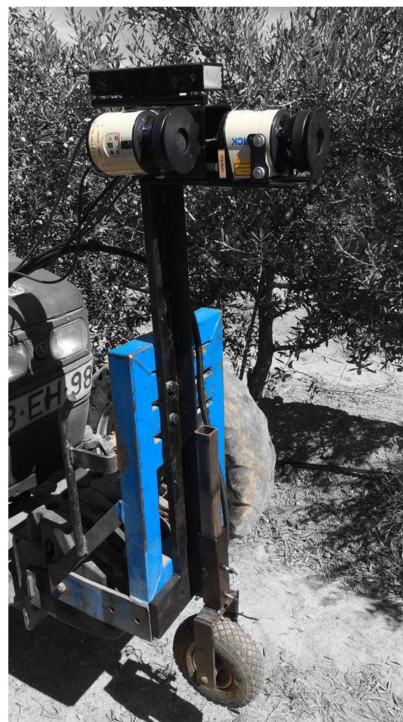
Two LiDAR LMS111 (SICK AG, Waldkirch, Germany) sensors were installed with different orientations on a dedicated platform attached to the front of a tractor at a height of 1.55 m above ground level, vertically (facing upwards) and laterally (facing sideways) (Figure 2). The LiDAR technical features are summarised in Table 1. The purpose of this scan configuration was to compare the data collected by each sensor. Point clouds generated by the vertically installed LiDAR sensors were filtered to obtain the same tree's lateral projection with both sensors. The LiDAR sensors were interfaced with a computer through an RJ45 Ethernet port for data transfer. The resolutions of both LiDAR sensors in the direction of travel were greatly affected by the tractor speed. Maintaining a constant speed was a key factor for obtaining accurate measurements. LiDAR data were recorded using a self-developed Lab View program (National Instruments Co., Austin, TX, USA). Both LiDAR sensors collected distance values in 271 directions (corresponding to a scanning field of view of 270°) every 20 ms (50 Hz) at half-degree angular steps to obtain the lateral projection of the tree with both sensors.

Figure 2. Two LiDAR sensors were mounted on the front of the tractor in different orientations to scan the olive tree structure.

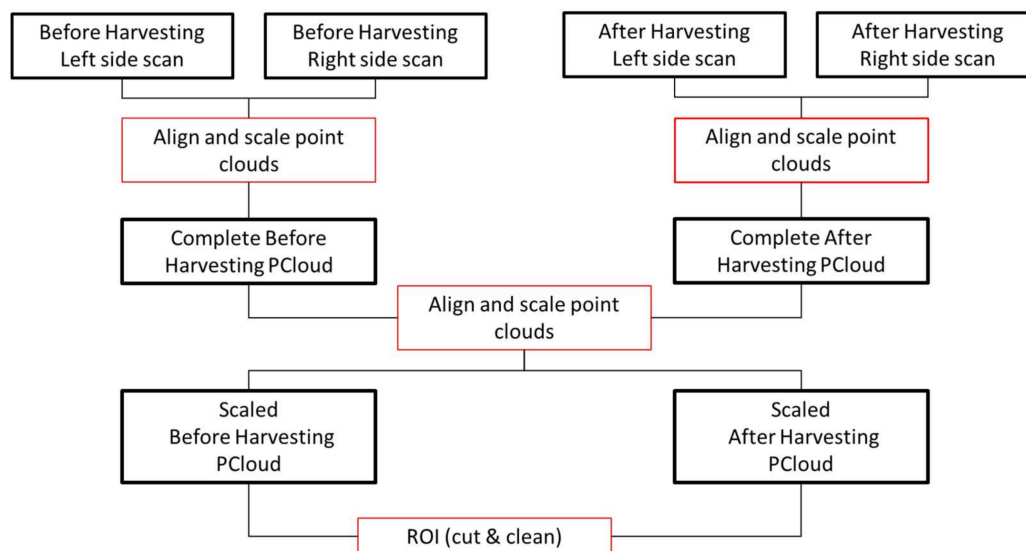
The alignment and filtering of the point clouds were performed using CloudCompare software (CloudCompare 2.9.1 GNU License, Paris, France) in the following sequence (Figure 3): (1) The scanned row was delimited in the raw data using physical references and a filter distance, so that the maximum values of the Y and Z point coordinates (while the X coordinate corresponded to the advance of the tractor) considered to belong to that row were limited in the point cloud representation software; (2) The point clouds generated by LiDAR 1 (facing sideways) and LiDAR 2 (facing upwards) corresponding to the scans on the left and right sides were aligned and scaled manually. In this manner, both point clouds (left and right) were merged as follows: In the CloudCompare software a manual selection of known and immutable points belonging to the fixed references (pre and post-harvesting) was performed, and both point clouds were aligned using its alignment tool, based on calculating the transformation rigid transformation matrix. An RMS error of less than 3 cm (average RMS error =

2.51 cm) was maintained in all alignments; (3) Pre- and post-harvesting point clouds were generated and aligned in the same manner; (4) The point clouds were simplified and cleaned by removing the data corresponding to the ground and ruling out points for being out of the study area. For this purpose, fixed box-shaped references were used as follows: a rectangular region of interest (ROI) was defined, delimiting as study elements the points between the upper inner corners of the boxes (30 cm height above the ground) and their vertical projections.

Figure 3. The workflow scheme for point cloud alignment and filtering for each LiDAR orientation.

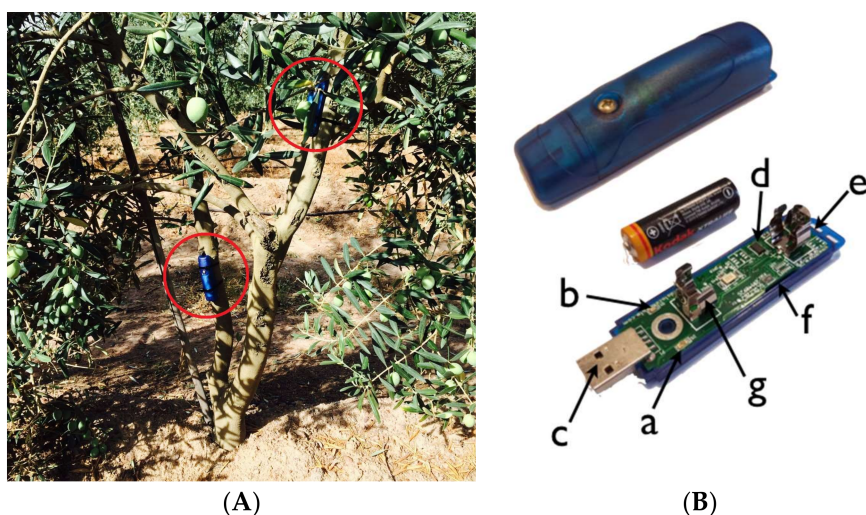
Acceleration was measured using four compact self-recording accelerometer data loggers (USB Accelerometer X16-1D, Gulf Coast Data Concepts, Waveland, MS, USA) that were set to record the acceleration (maximum of 16 g) in 3 separate axes at 100 Hz. The accelerometers present a 16-bit resolution, or 65,536 discrete counts, covering the full range of ± 16 g. In this way, 2048 counts/g were obtained. The accelerometers were battery powered (type AA), and their weights and dimensions were 55 g and $26 \times 26 \times 104$ mm, respectively. The data from the digital accelerometers were time stamped using a real-time clock (RTC) and then stored on a removable microSD card (8 GB) in simple text format. Two USB accelerometers were strapped to each tree, split between two primary branches at different heights from the ground (Figure 4).

Figure 4. Three-axis accelerometers mounted on an olive tree (A) and the X16-1D accelerometer (B): a: the red LED data indicator, b: the blue LED status indicator, c: a type-A USB connector, d: an ADXL 345 sensor, e: an on/off button, f: a microSD card (under the circuit board) and g: the AA battery holder.

The accelerometers were placed in different positions and branches on the same tree, to ensure that the axes of the accelerations were varied and lateral and that forward movements did not correspond to the same coordinates of the space between the accelerometers. For the analysis of these forces and accelerations suffered by the olive tree during harvesting, proprietary software was developed and used in the statistical R software. For the sake of simplicity, the $x/y/z$ axes data were combined into a single vector sum (RMS) prior to their analysis. This process combined all directions into one summed value to ensure that the values could be compared between different trees without the need for equal orientations of the accelerometers.

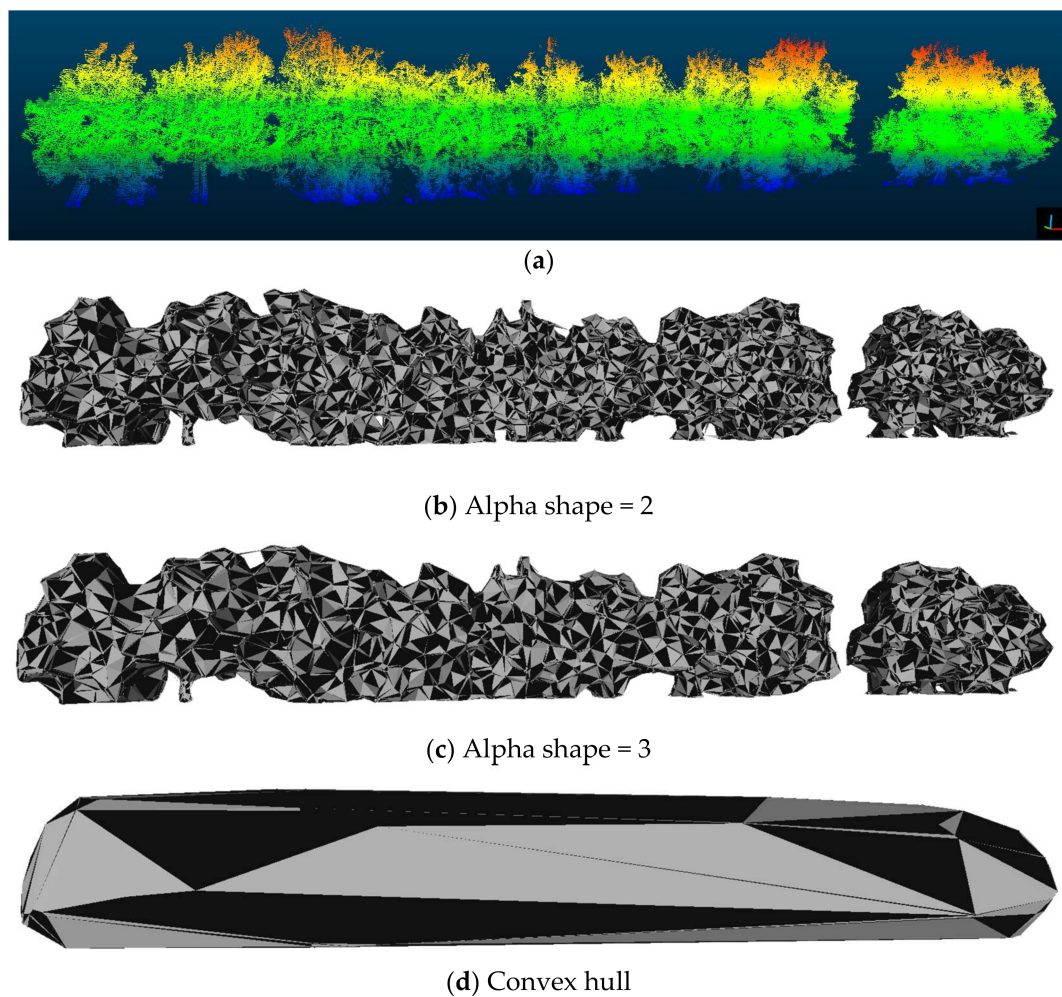
As shown in Figure 5, some of the plots missed some trees. In these cases, the volume of the tree wall was calculated separately, grouping the two large sets of trees together (as in the left part with eight trees and the right part with two isolated trees). This process avoided the calculation of the space that would “occupy” the missing tree, and it generates a fictitious value.

Figure 5. (a) A tree-row point cloud representation coloured by height; (b) a tree-row surface reconstruction using the α -shape algorithm with an α value = 2; (c) a tree-row surface reconstruction using the α -shape algorithm with an α value = 3; and (d) a tree-row surface reconstruction using the convex hull algorithm.

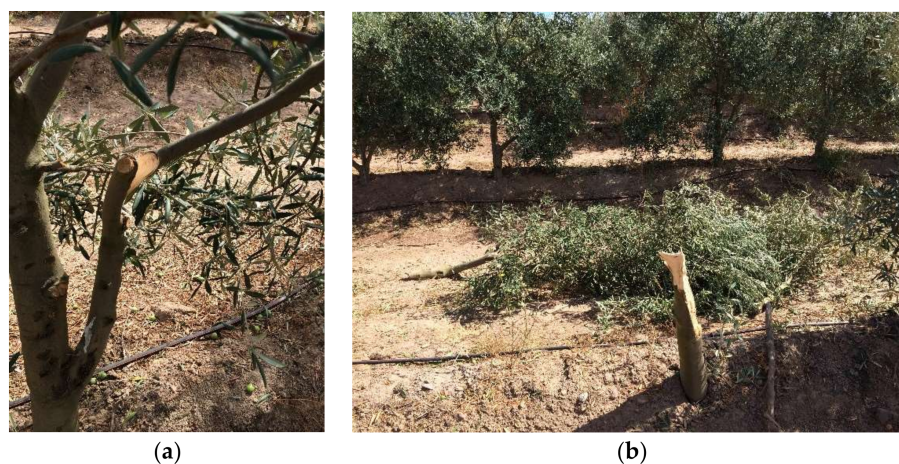
Figure 6. Olive tree with branch damage (a) and a tree tear (b) caused by the harvester in the same commercial field where the trials were conducted.

A total of 36 olive trees were monitored using USB accelerometers to measure and record the vibrations in the trees in both experimental trials. Table 6 shows the maximum root mean square acceleration (RMS) and the vibration time of the tree recorded by the accelerometer. An increase in the beating frequency (from 430 to 470 Hz) caused an increase in the maximum acceleration of 40% in the ‘Manzanilla Cacereña’ variety and 70% in the ‘Manzanilla de Sevilla’ variety. A change in the nominal speed of the harvester did not result in any significant differences in the maximum acceleration, however; but it reduced the vibration time per tree by 20%. At the maximum frequency, it was possible to break the branches or even to cut the olive trees (Figure 6). This plant damage may be an indirect cause of concealed losses [36,37].
